PHOTO LOG**W 13008**

Wesco/Lander field

SPCC Inspection 6 June 2013

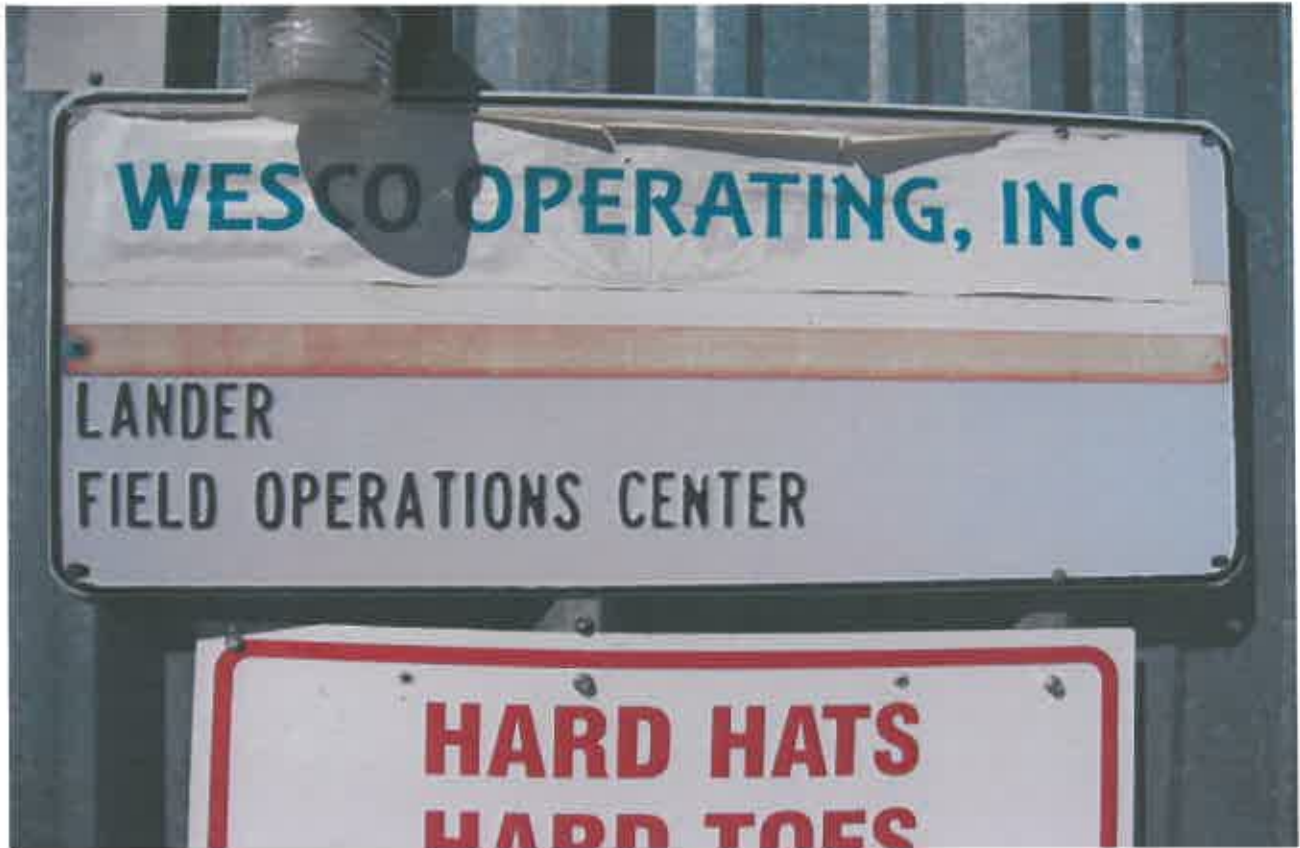
01: Facility ID sign, with no telephone information nor geographic location data, details on some site safety regulations.

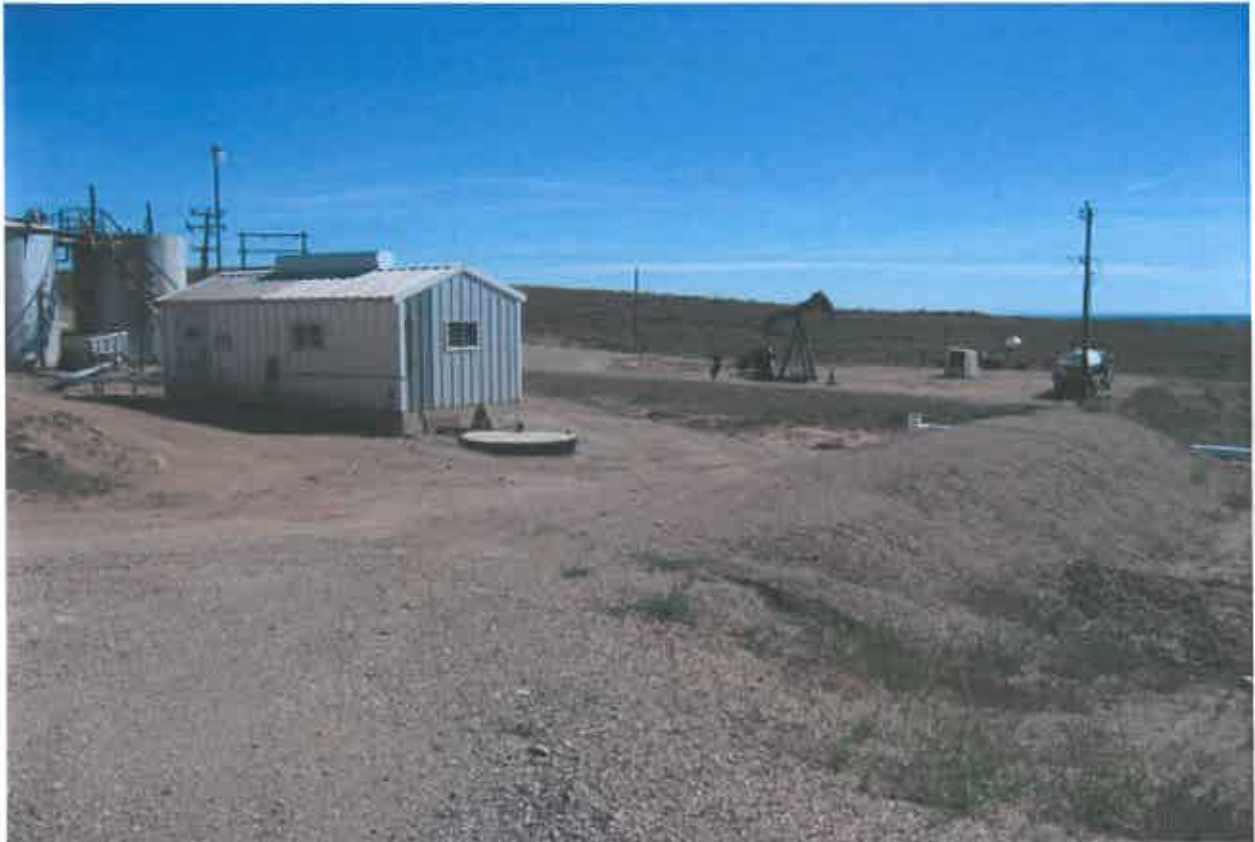
02: Front (south) view of facility showing perimeter berm wall, sump vault, Recycle pump shed and water/oil release siphon. Perspective to northeast.
WESCO/ Lander field **W 13008** 6 June 2013

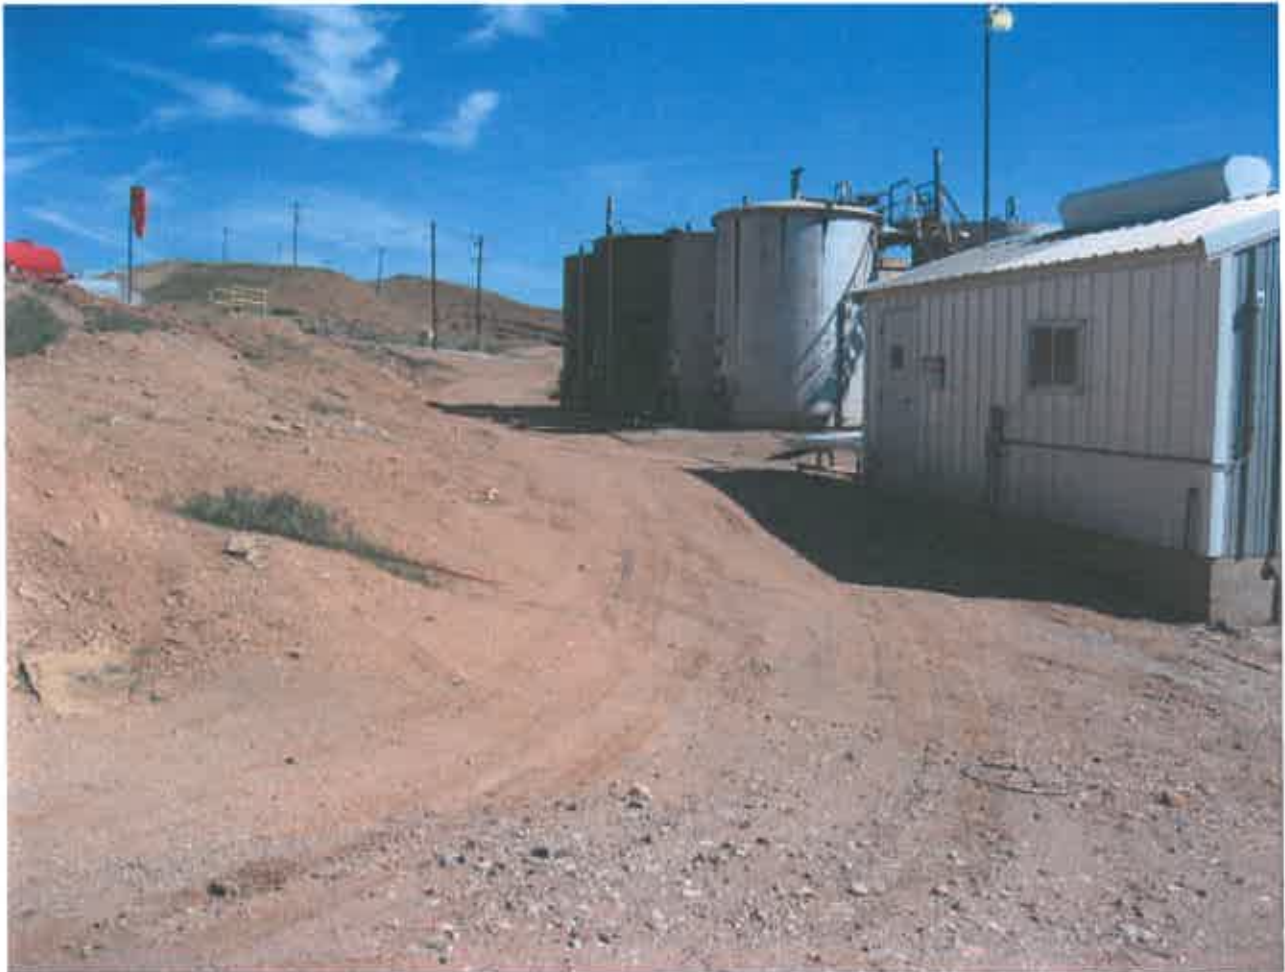
03: Access roadway coming downhill with recycle pump building and 300 bbl Indian lease crude oil AST.

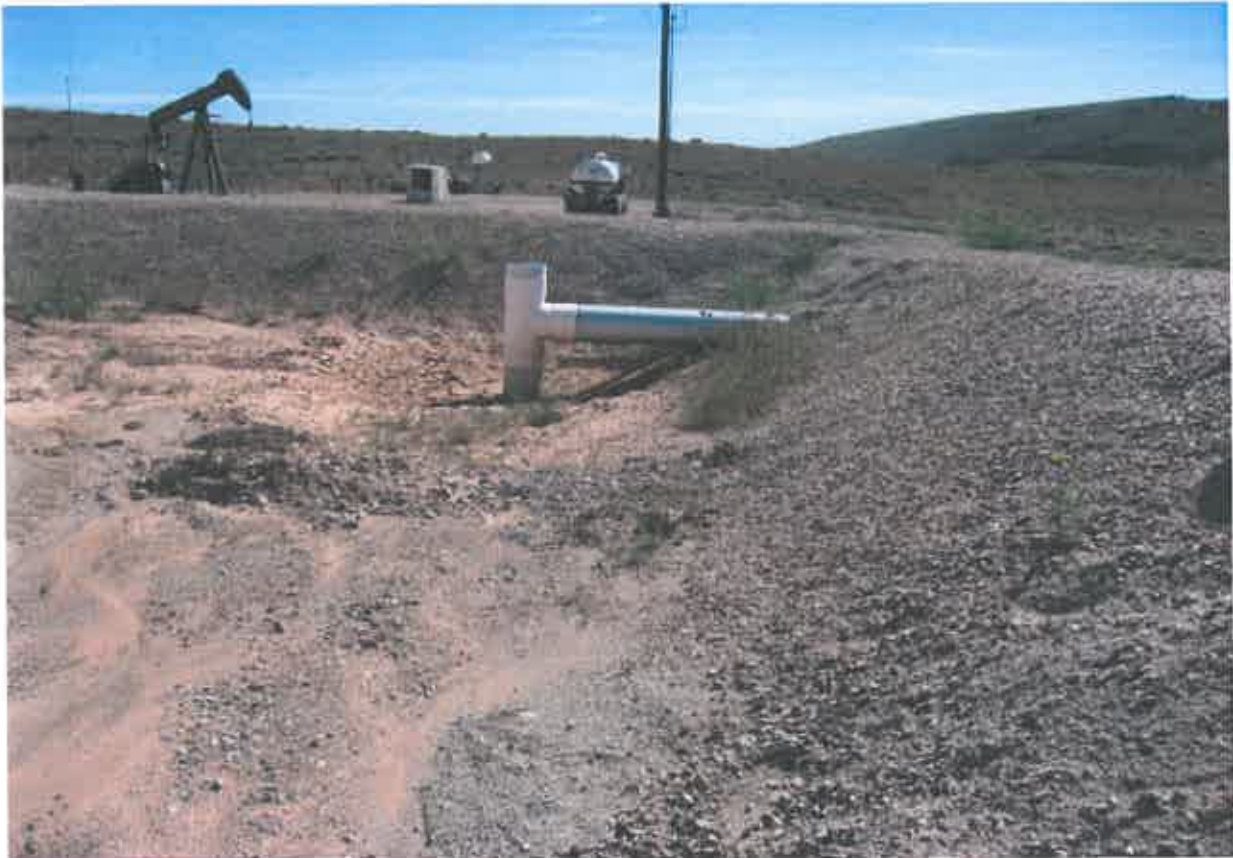
04: Sump siphon located at SE corner of containmnet area of facility, bottom of Slope. Photo shows 4' wide by 7' high perimeter berm wall on east side of facility. Siphon designed to allow water to flow out from top of spill burt oil to remain trapped within containment area.

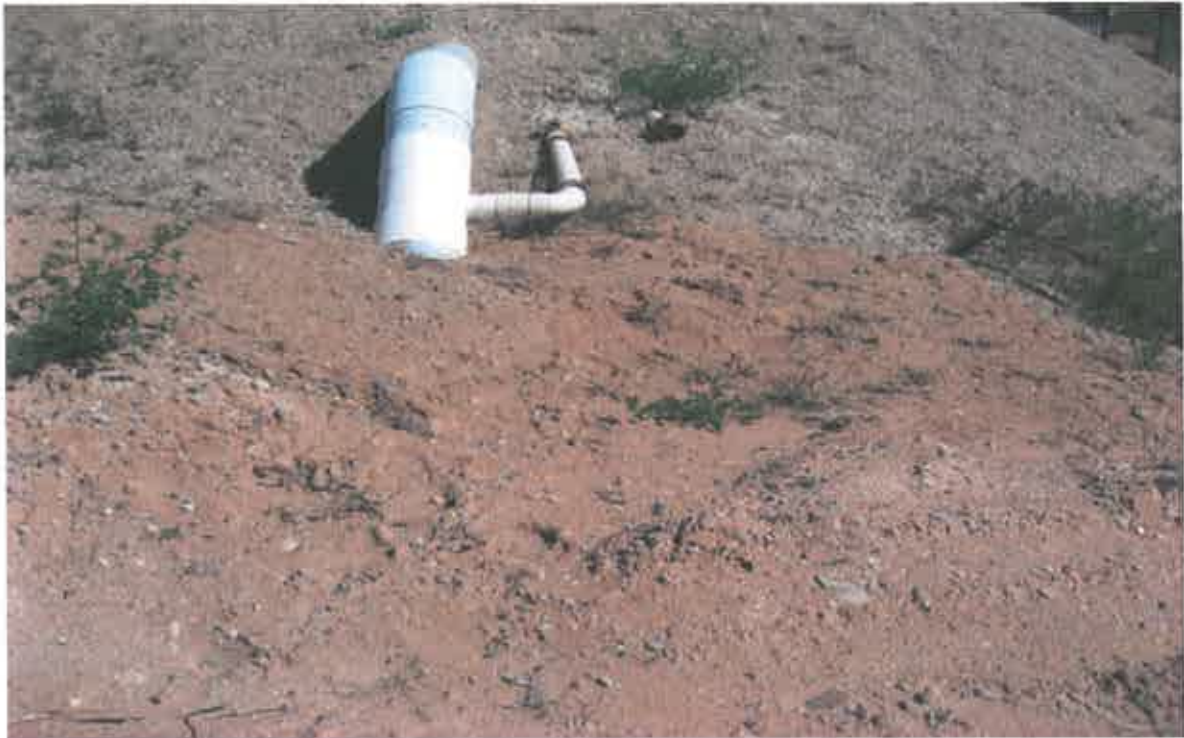
05: Downhill side of siphon, outside containment berm wall, area where water only will exit from siphon if spill occurs. Any water through siphon will end up in Safety pit #14, 4' deep. Perspective is south.

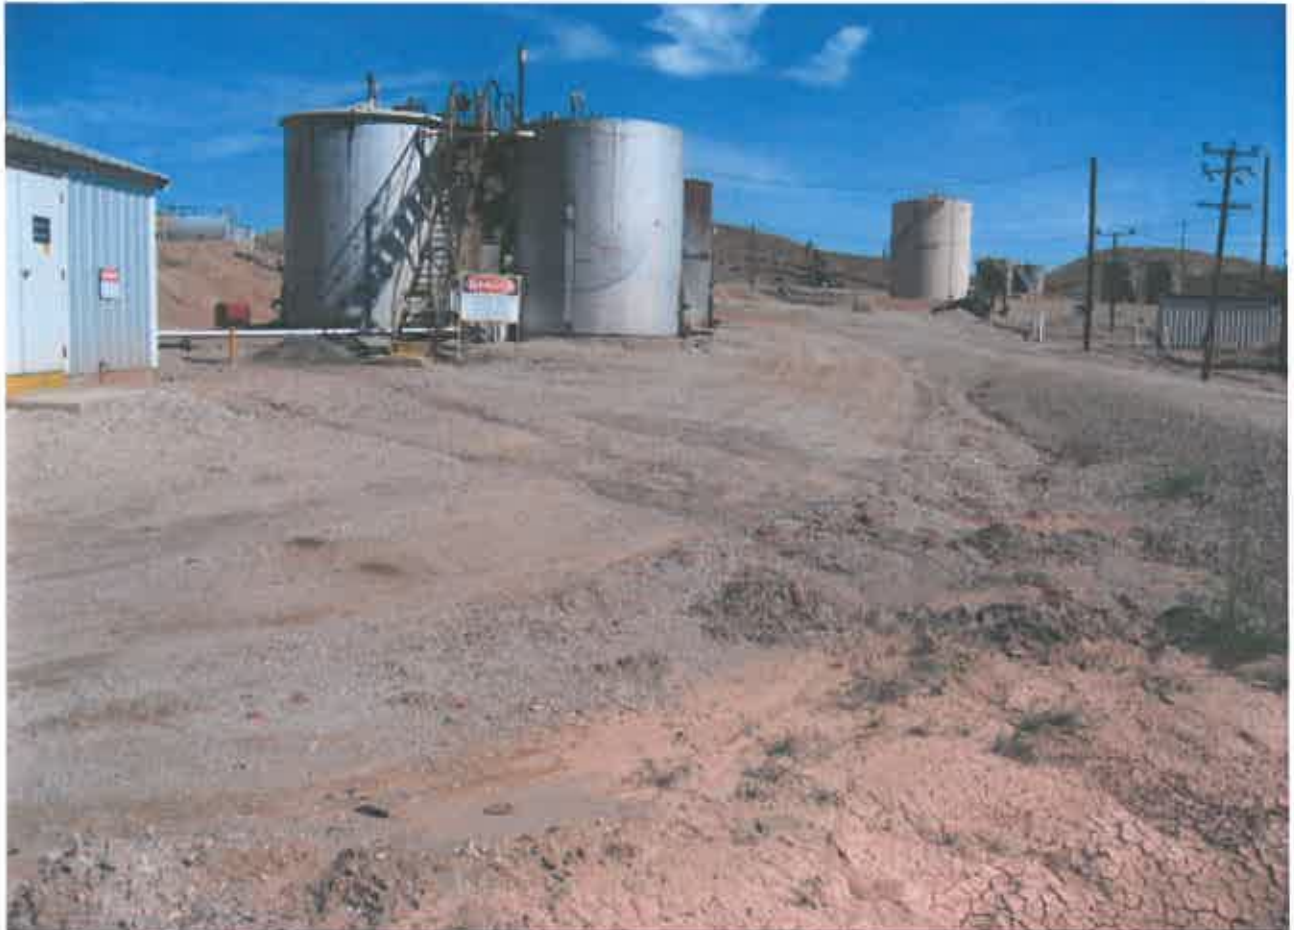
06: View of four ASTs, 3 x 500 bbl and 1 x 300 bbl. These ASTs hold crude oil From private land leases. Access road coming downhill from north, higher elevation of facility property.

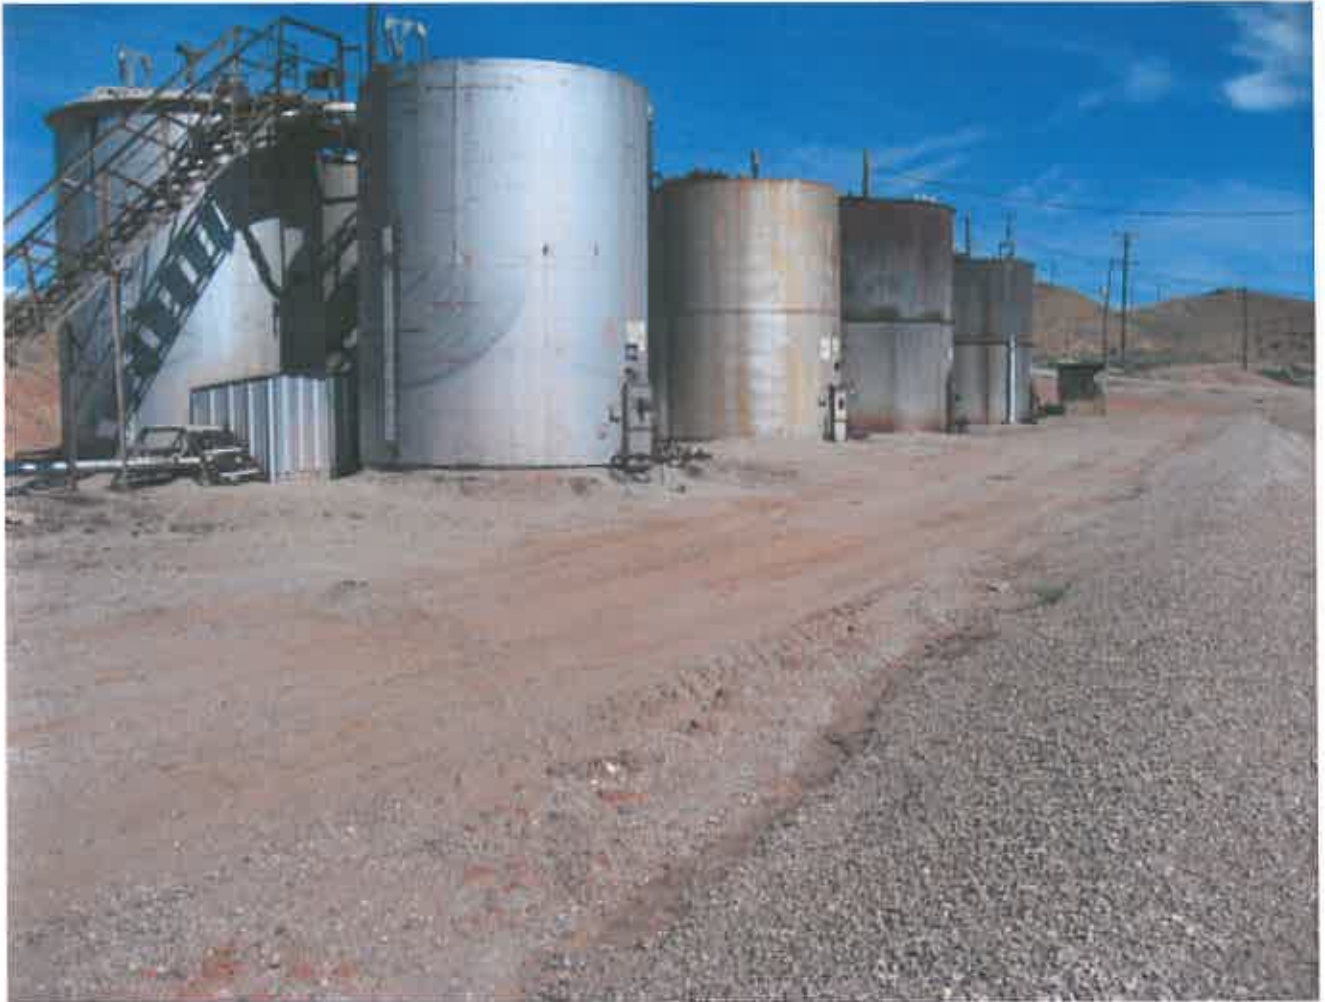
07: AST battery with eight (8) tanks; 3 X 300 bbl WS tanks holding Indian lease crude oil, 4 X 500 bbl and 1 X 300 bbl containing crude oil from private property lease land. The 300 bbl PA-1 is WS (welded steel) remainder 500 bbl tanks are BS-Bolted steel tanks.

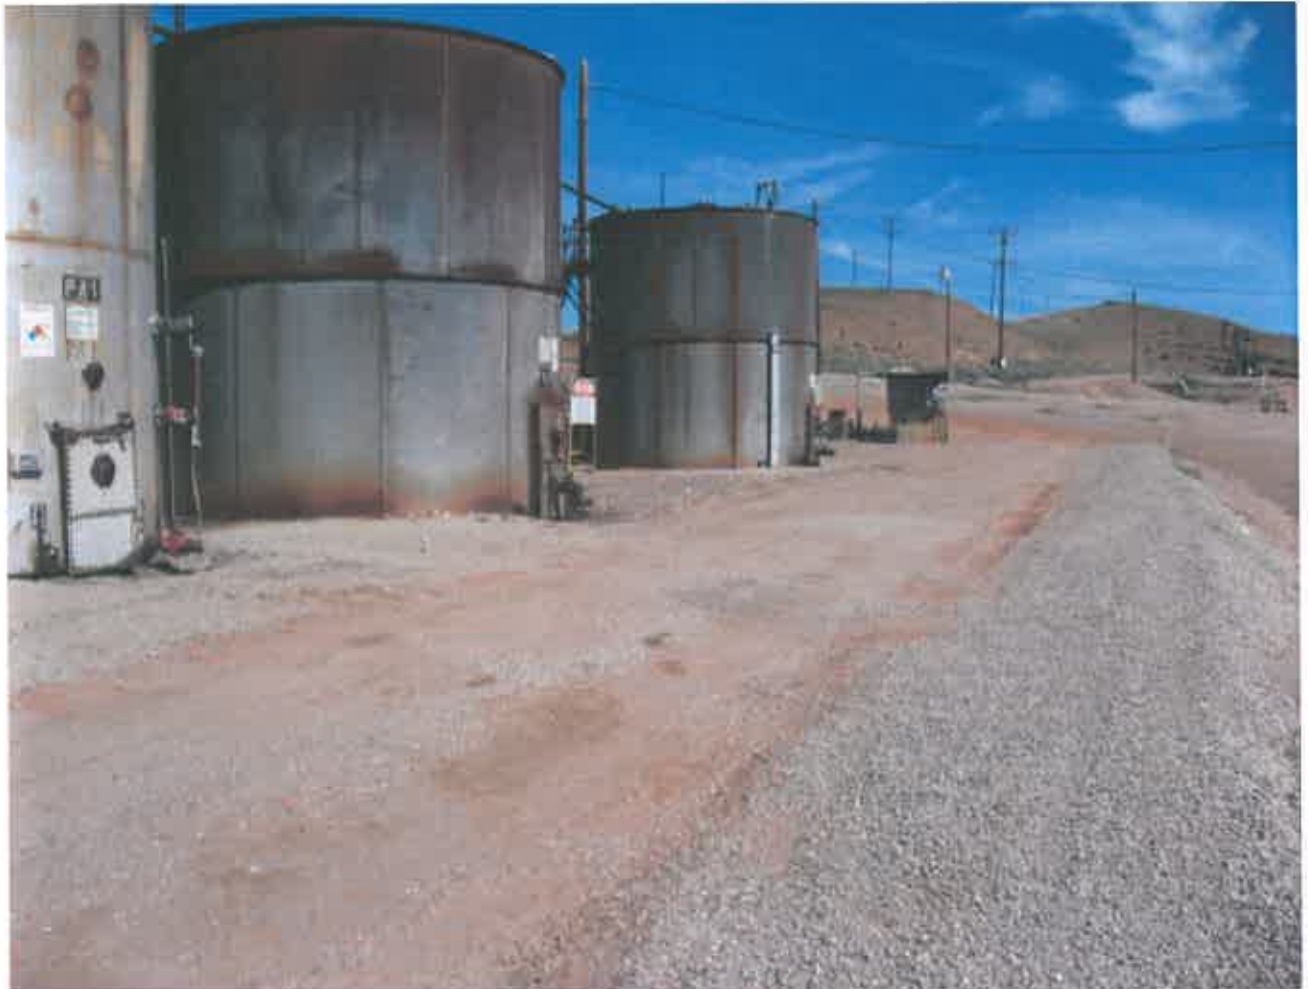
08: View of tanks: PA-1 (WS), PA-2 and PA-5 both tanks bolted steel. Tank PA-5 is PA system transfer tank.

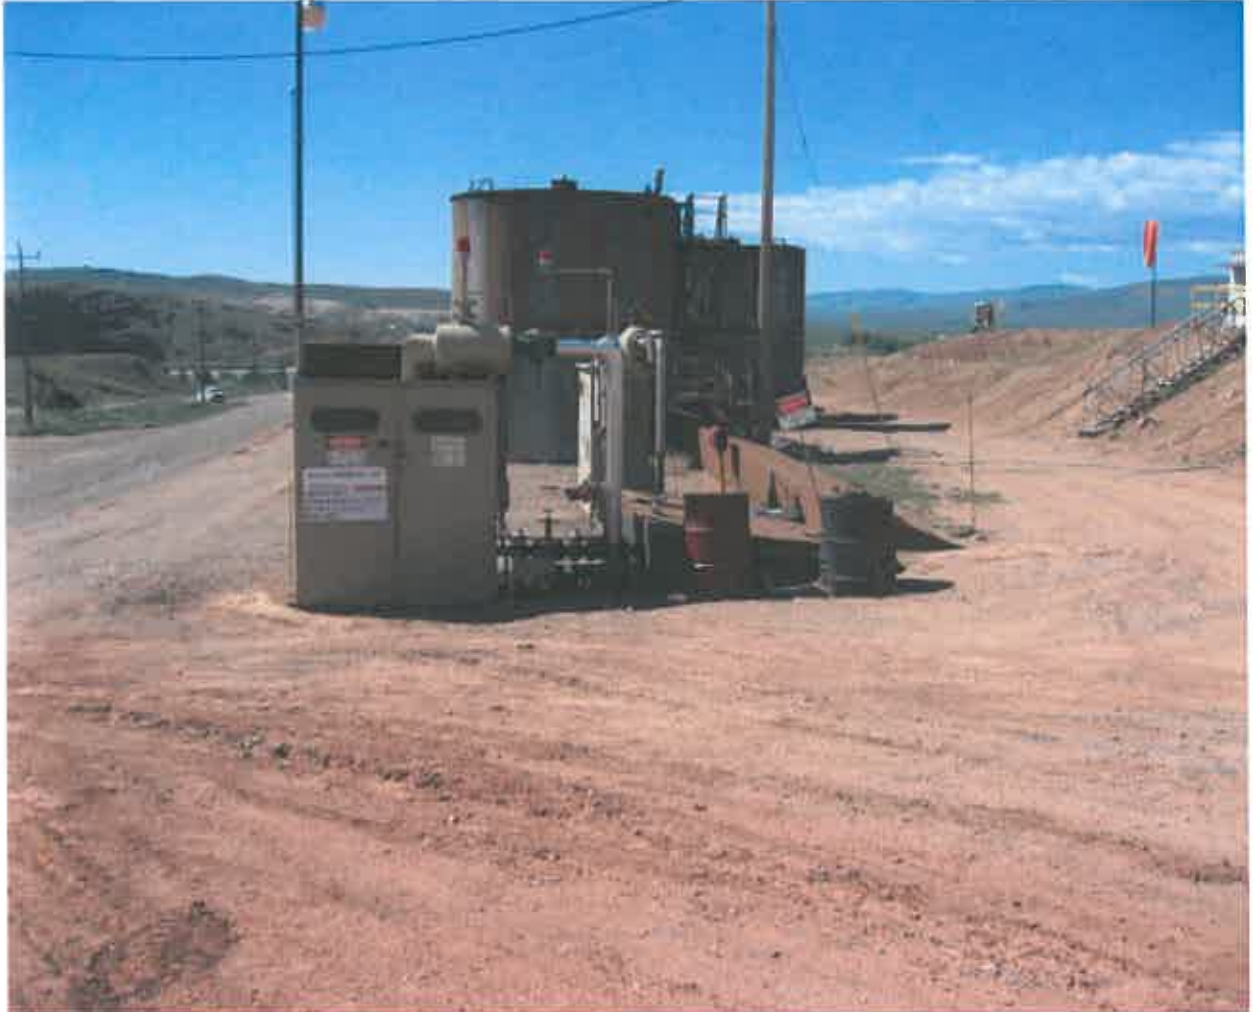
09: LACT (Lease Automatic Custody Transfer units) for Indian and private lands lease oil transfer. Oil sample drums for each type oil in right foreground of photo. Photo shows area just north of tanks shown in photo #8.

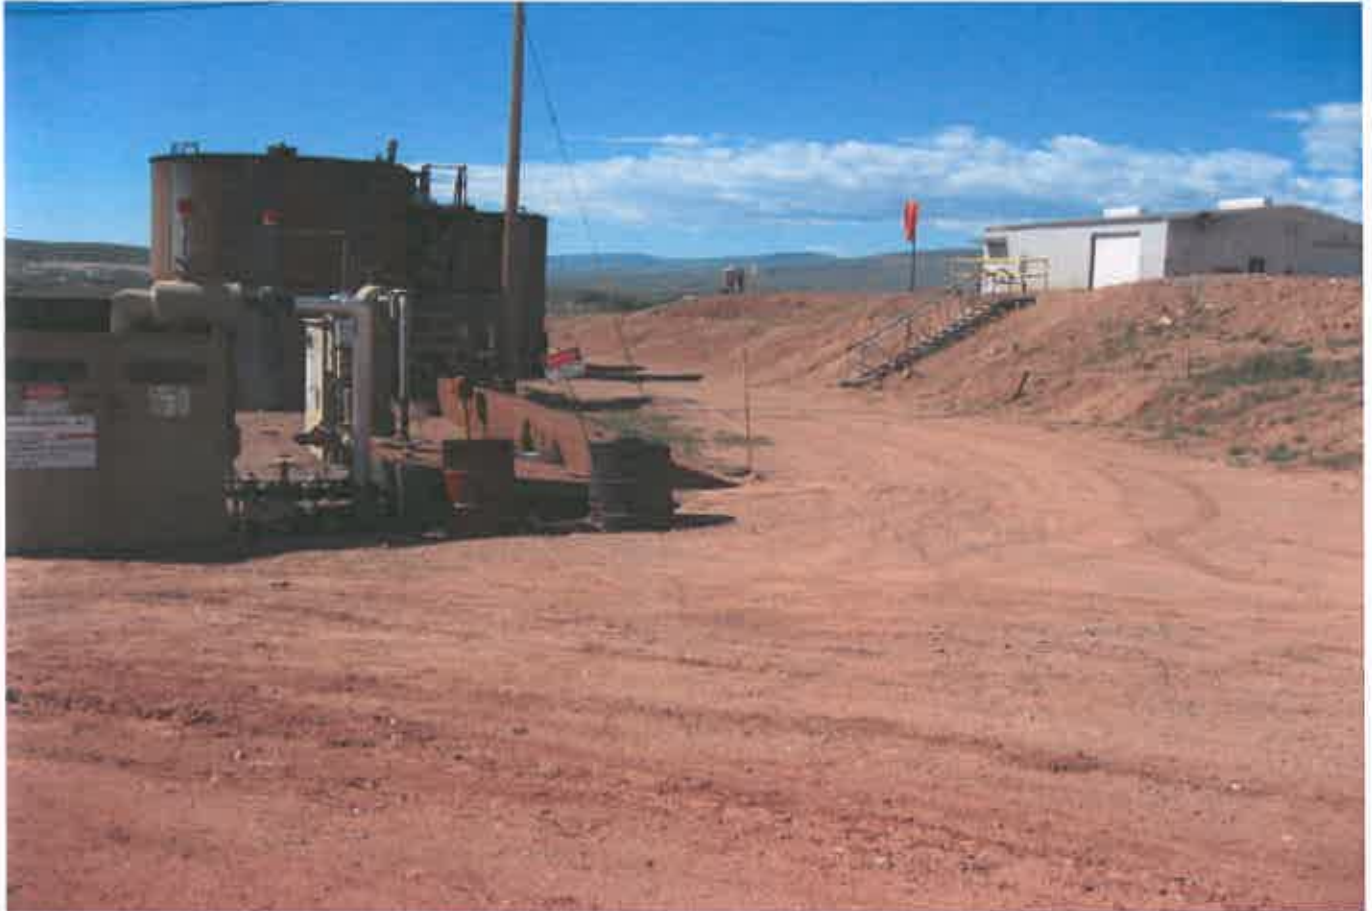
10: Additional view of LACT units, with sample oil 55 gallon drums for each type oil, upslope to right of drukms integrated into perimeter secondary containment system. Perspective is south.

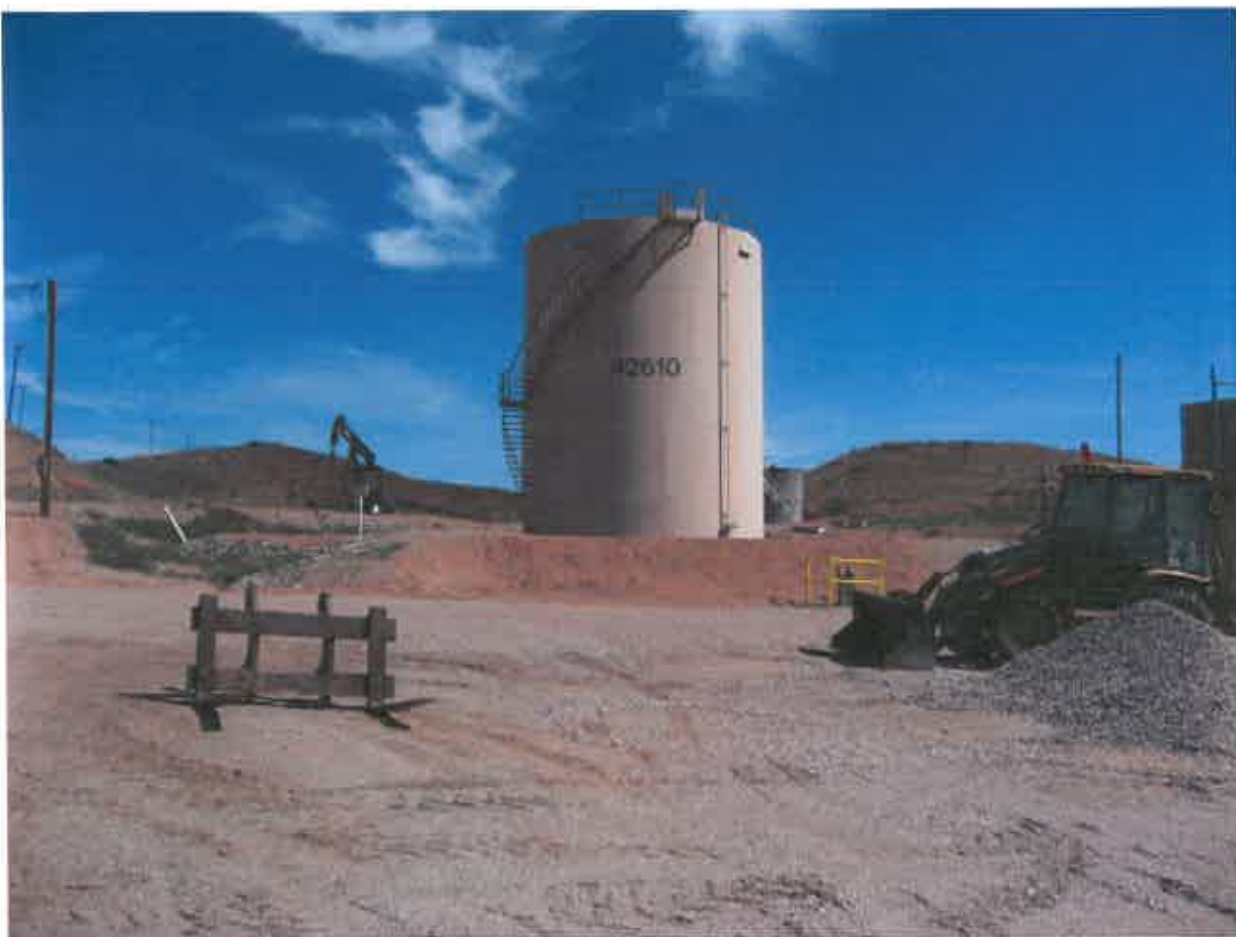
11: New 5000 bbl capacity AST within specific secondary containment basin system. View is uphill in northerly direction.

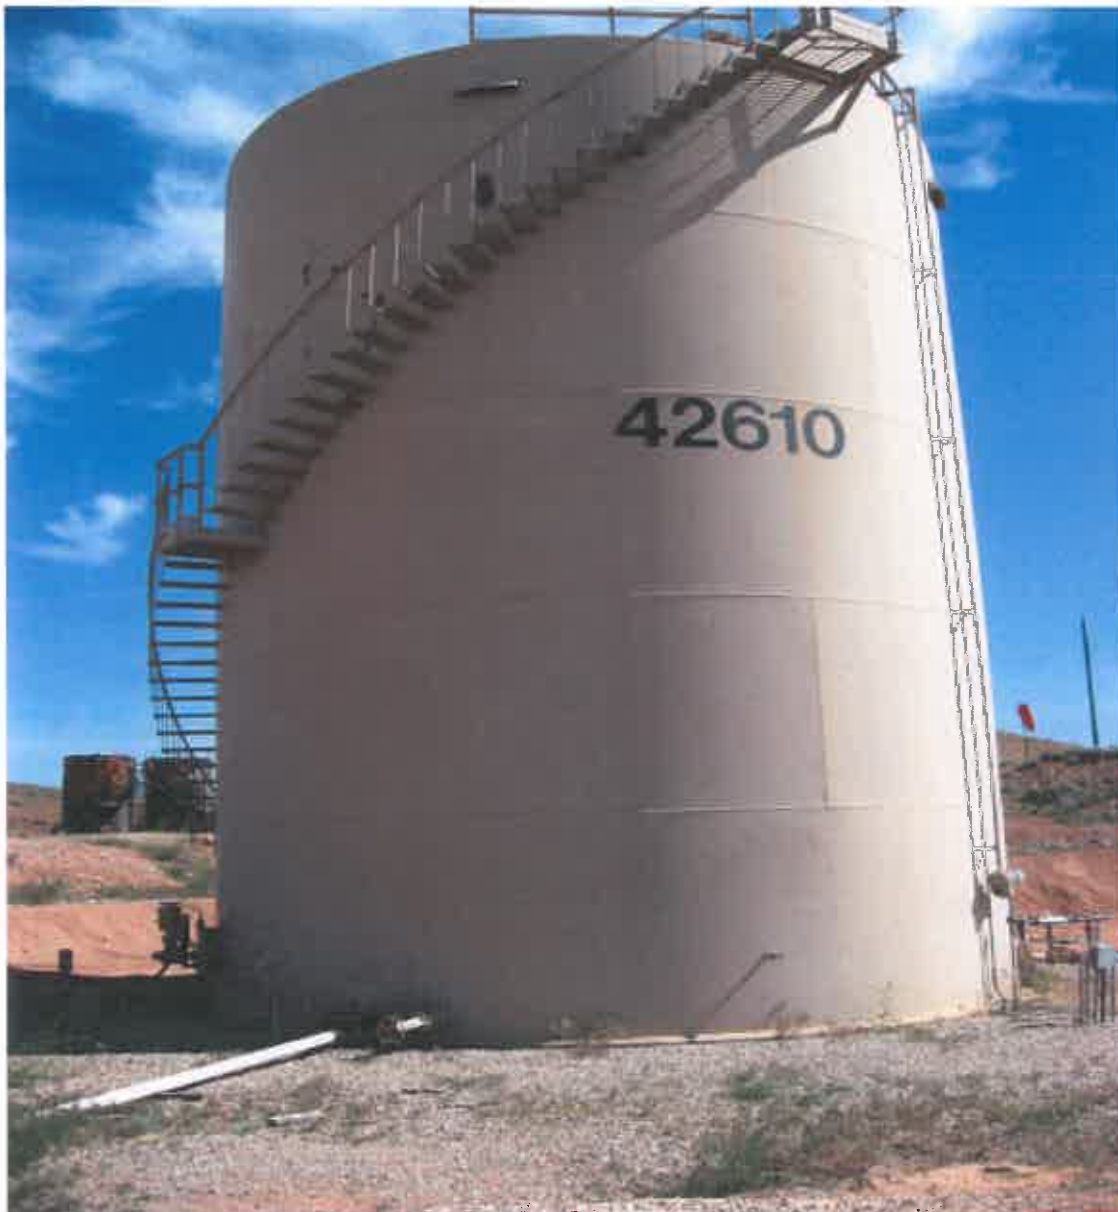
12: Close up view of new tank #42610 500 bbl crude oil AST. Looking uphill to The north.

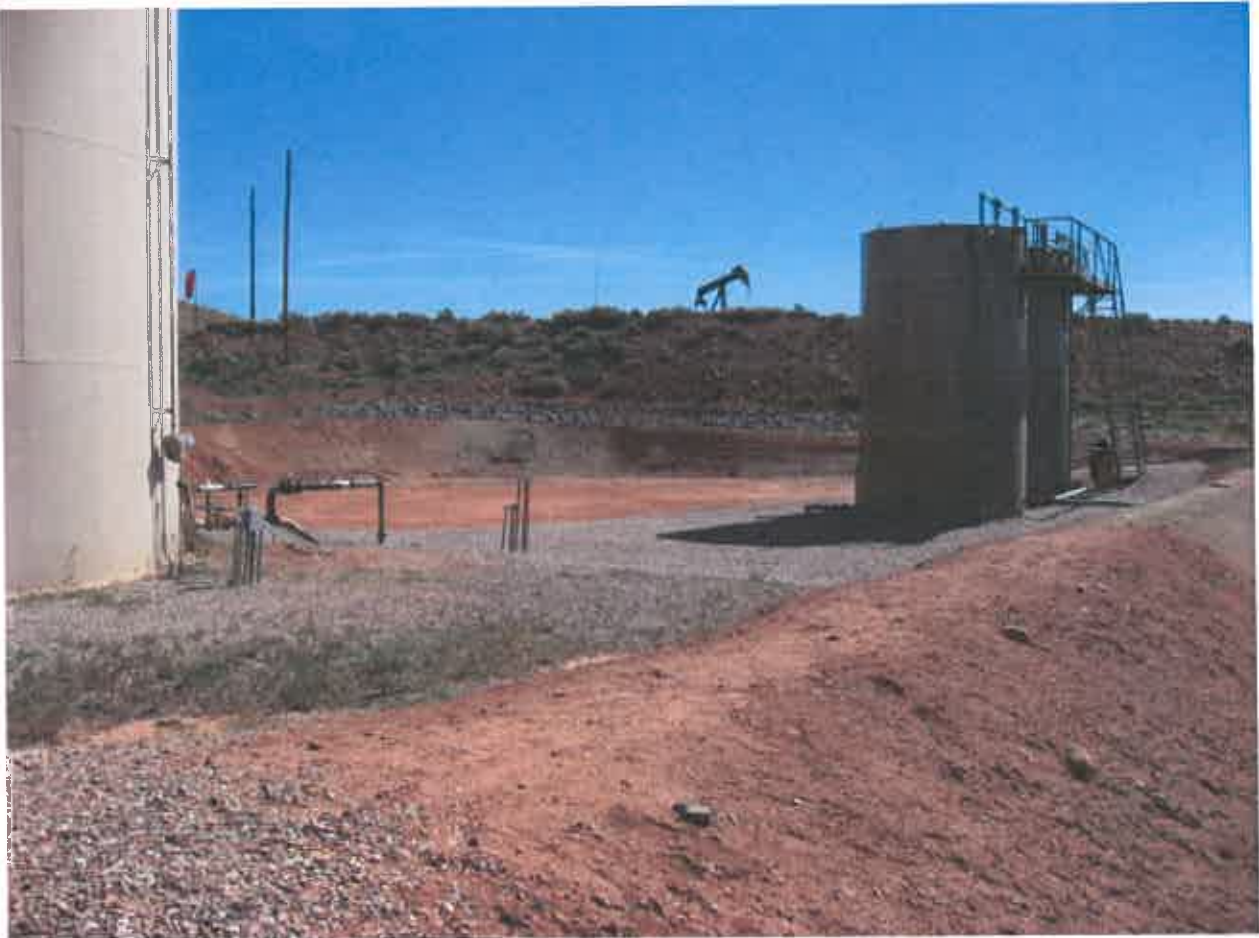
13: Two smaller 400 bbl crude oil tanks also within the basin secondary berm wall. Perspective is north.

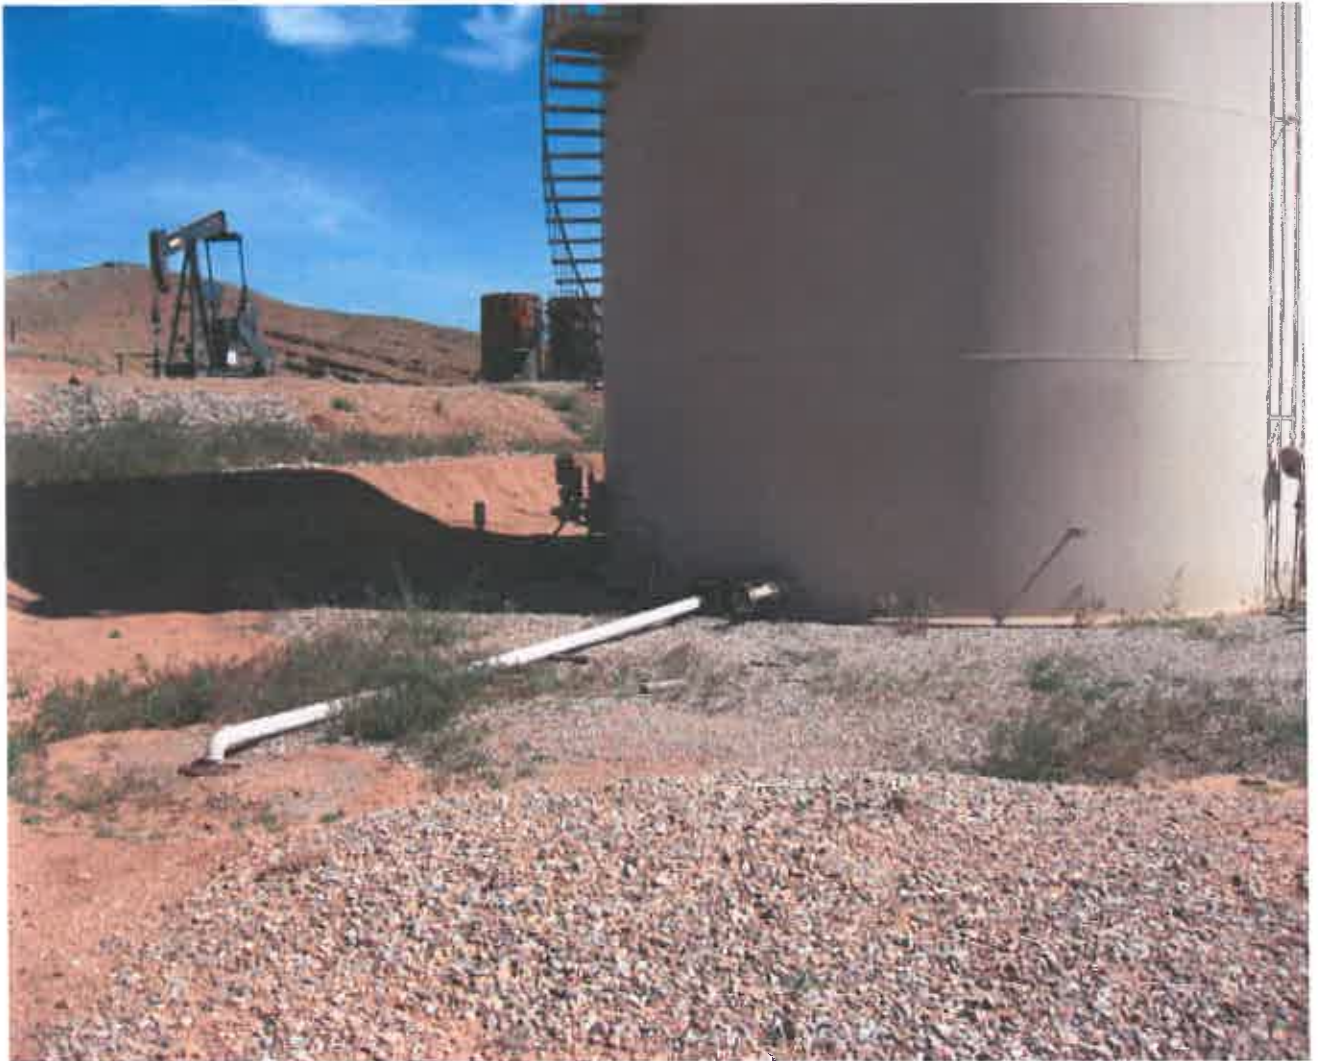
14: Plastic pipe drains oil out of 5000 bbl AST to unload station below, note Valve control unit; two out of service old ASTs uphill.

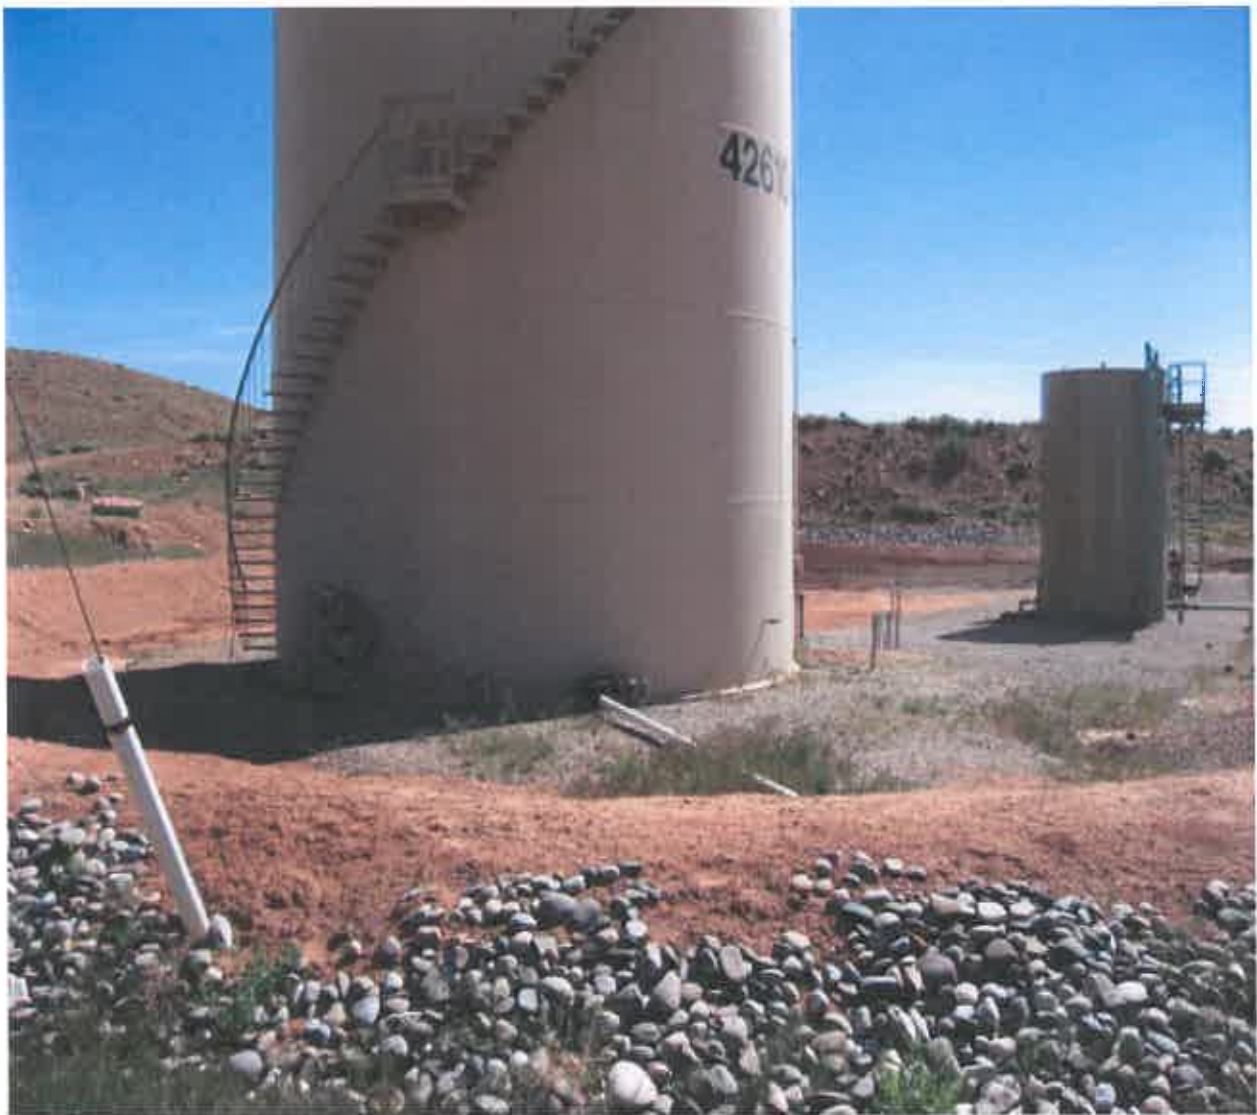
15: View of AST #42610 (5000 bbl) and two 400 bbl ASTs within secondary containment basin.

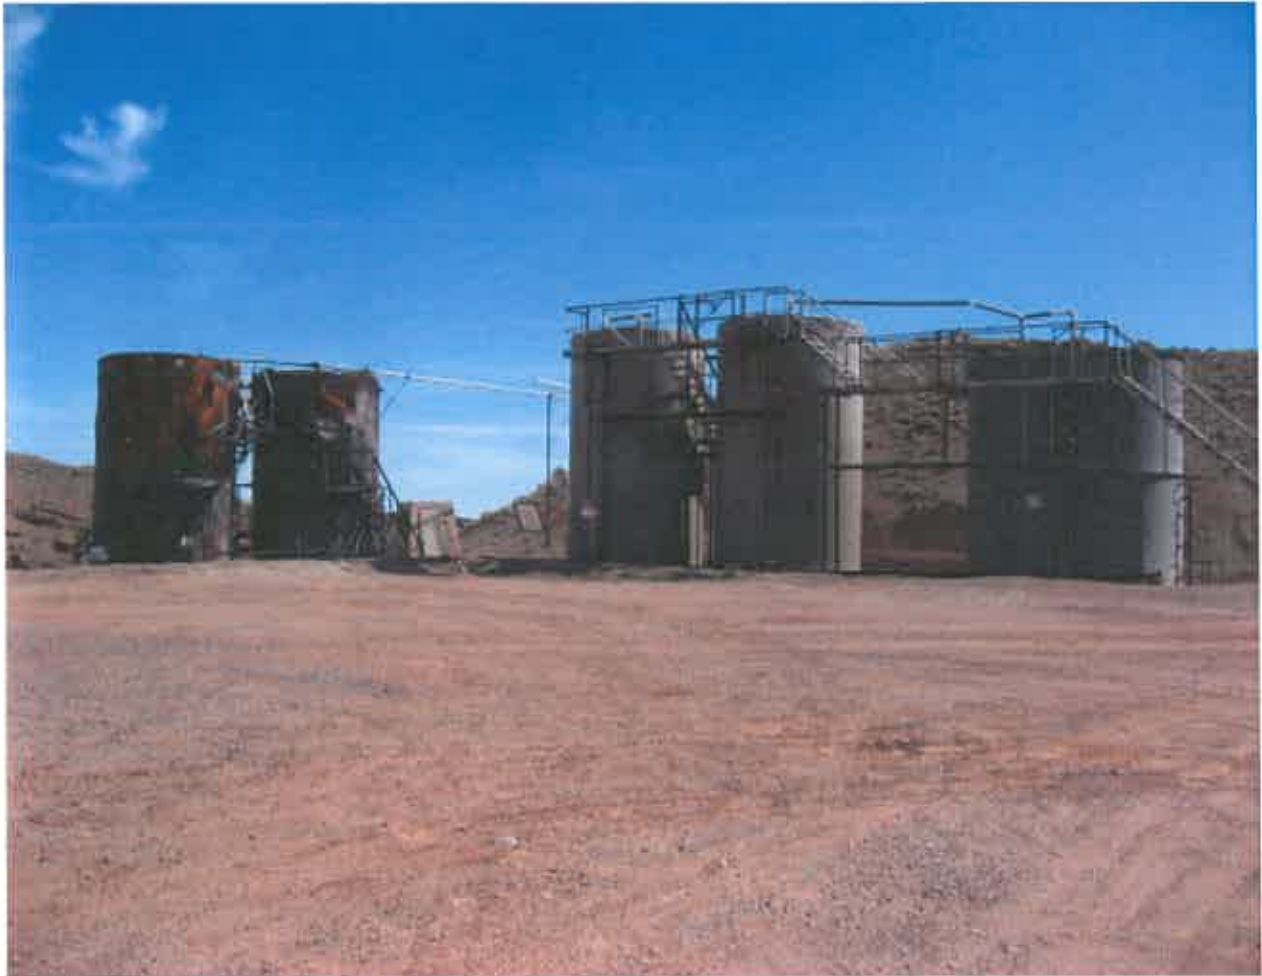
16: Two heater coiled insulated "bad oil" ASTs, with three crude oil ASTs ; #1, 2,3 left to right in photo, small shed between is anti-freeze heat shed. This sector is near the top of the slope of the north-south axis of the facility.

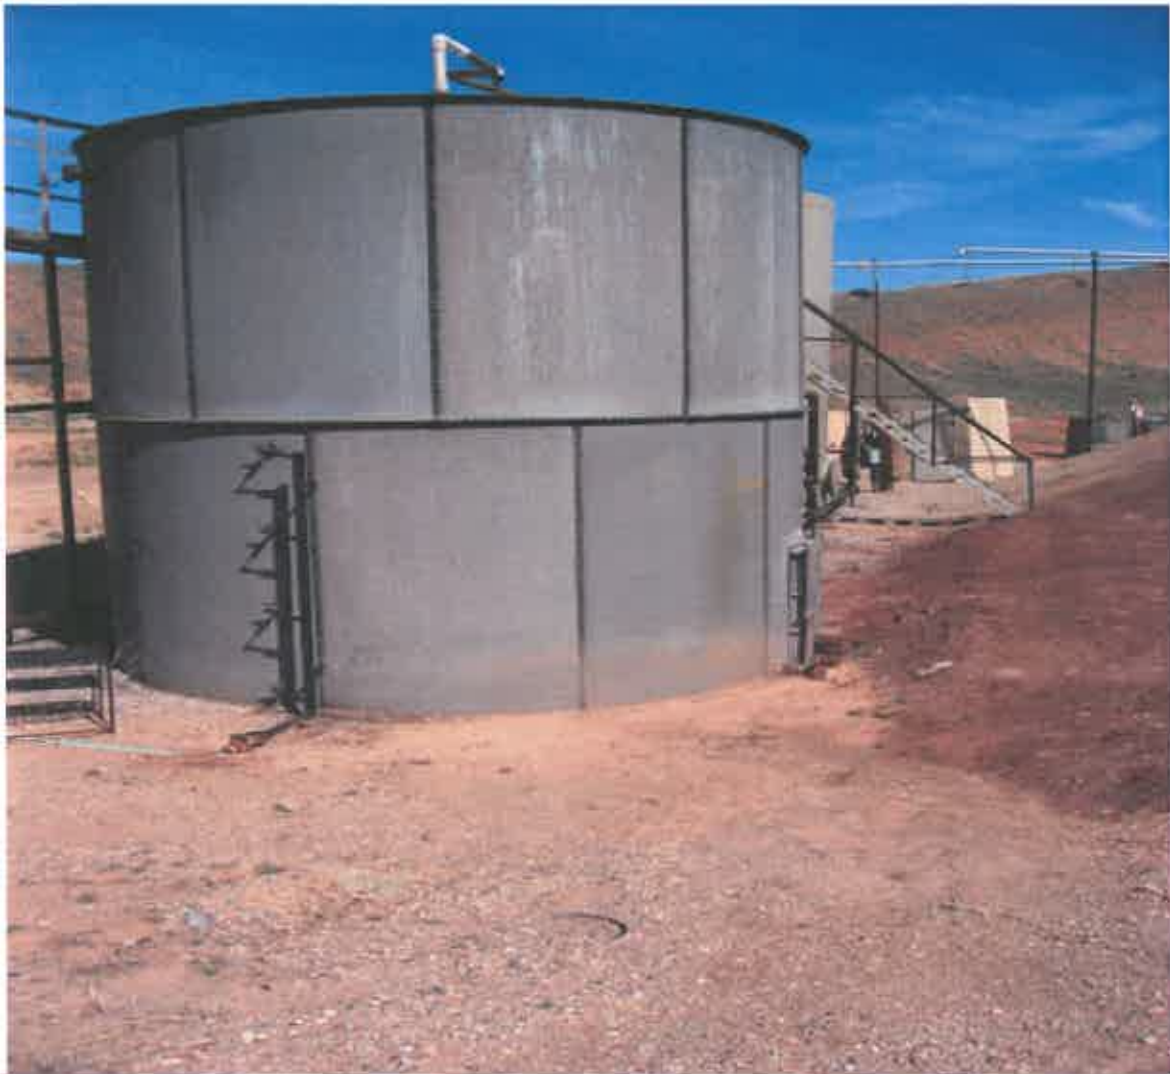
17: Newly installed bolted steel AST, at top (north) sector of Lander field site.
Perspective is to north towards crest of hill.

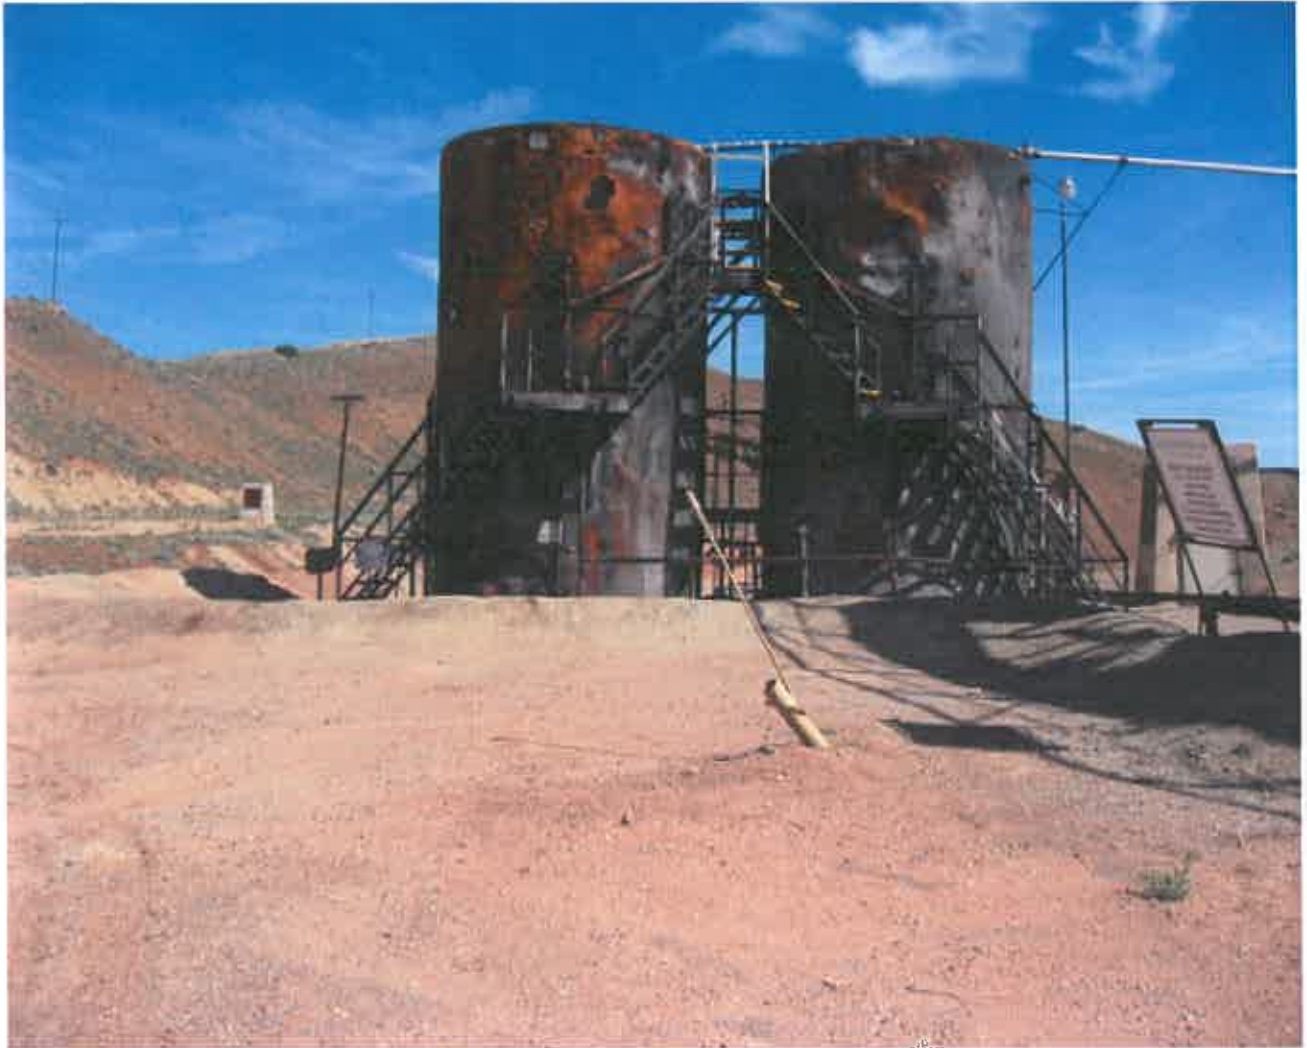
18: Two insulated heater coiled "bad oil" ASTs formerly used in oil recycle process, located in the northern most sector of the Lander field operational site.
WESCO/ Lander field **W 13008** 6 June 2013
